SENENICH PROPELLER CO., INC.

SERVICE BULLETIN SB2016-06

SUBJECT: Inspection of adjustable pitch jabiru hubs for cracks

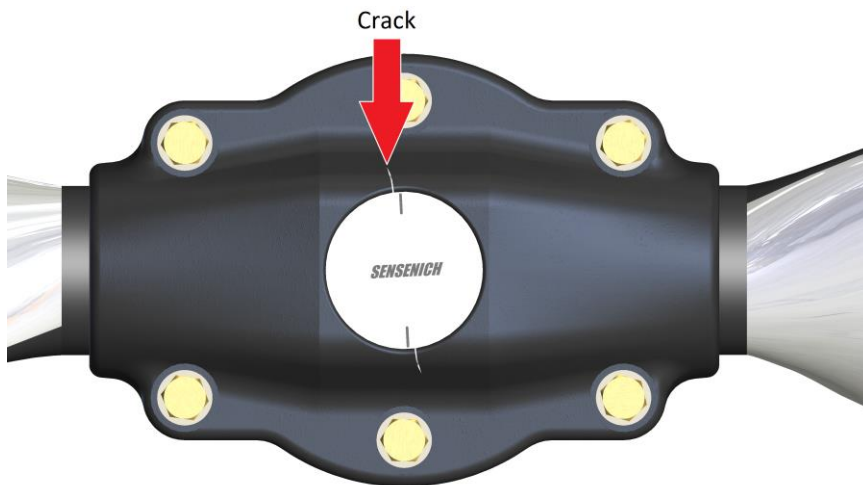
REASON: Sensenich has received reports of cracked hub covers on several tractor and pusher installations with Jabiru engines.

Figure 1. Cracks start near pitch marks and grow outwards.

- Inspect hub for cracks before next flight.
- Remove spinner dome (and front bulkhead, if used). Closely inspect the hub cover (clamp half) around the pitch cylinder and on the hub sides. Also examine the sides of the hub mount half. See Figures 1 and 2.
- Notify Sensenich of any crack occurrences and return hub for evaluation.
- Inspect hub for cracks every 50 hours or annually.
