# SENENICH PROPELLER MANUFACTURING COMPANY, INC.

## SERVICE BULLETIN #R-8-1 SEPTEMBER 22, 1961

**SUBJECT:** INSPECTION OF SENSENICH PROPELLERS; APPLIES TO M74DM PROPELLERS, EXCEPT THOSE WITH SERIAL NUMBERS PRECEDED BY THE LETTERS "A" OR "K", INSTALLED ON LYCOMING O-320-B SERIES (160 H.P.) ENGINES.

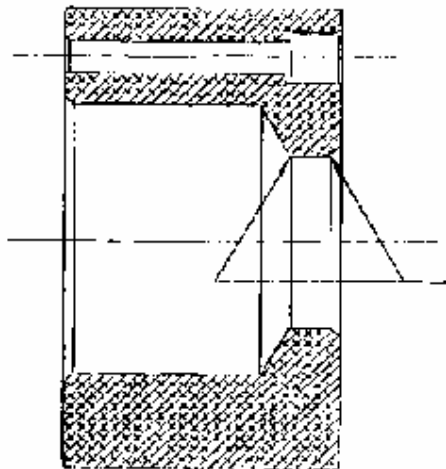
REMOVE PROPELLER AND VISUALLY INSPECT FOR CRACKS ORIGINATING IN PILOT BORE. IN CASE OF DOUBT, ANY OF THE APPROVED METHODS FOR ALUMINUM ALLOY INSPECTIONS MAY BE USED. IF CRACKS ARE FOUND, THE PROPELLER MUST BE RETIRED IMMEDIATELY FROM SERVICE. IF NO CRACKS ARE FOUND, POLISH OUT ANY SCRATCHES IN THE BORE AND BREAK AND POLISH ANY SHARP -EDGES APPEARING AT THE FRONT AND REAR CHAMFER OF PILOT BORE. (SEE DRAWING)

WHEN PROPELLER IS REINSTALLED, TORQUE RETENTION BOLTS TO 300 INCH POUNDS.

AFTER COMPLIANCE, PROPELLER SHALL BE REMOVED AND INSPECTED AT EACH ANNUAL INSPECTION OR EACH 100 HOUR INSPECTION, WHICHEVER OCCURS FIRST. PROPELLERS WITH CRACKS MAY BE RETURNED TO THE MANUFACTURER FOR POSSIBLE REPLACEMENT ON A WARRANTY BASIS.
