# SENENICH PROPELLER CO., INC.

## FAQ FOR SERVICE BULLETIN SB2016-06B

Service Bulletin [SB2016-06B](#) contains all the definitive information for model and serial number applicability. This FAQ provides supplemental information to illustrate the following: model and serial number identification, previous service bulletins, hub model progression and pitch system variations, crack location and inspection recommendations, blade retention redundancy, and options available for compliance with the service bulletin.

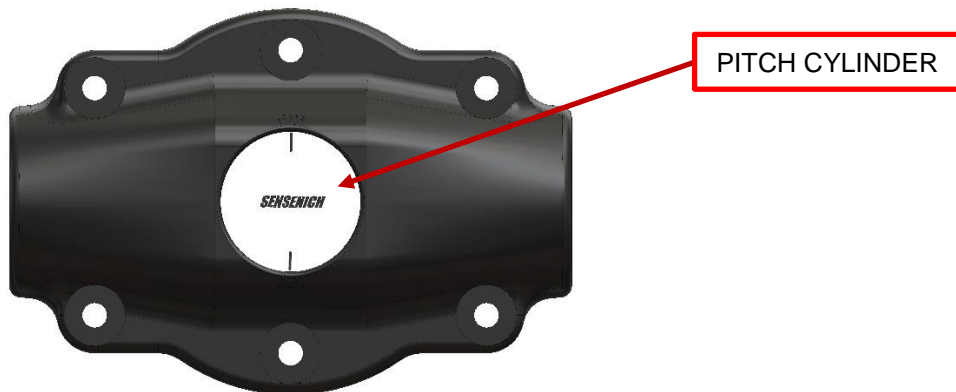
Figure 1. Hub Model 2A0 Series Revision "D" and earlier

*Identification is denoted by the presence of the white pitch cylinder.*

The serial number last digit indicates the revision level: If the last digit is a number, then it is revision "0", otherwise there is a letter such as "A", "B", etc...

Revision "D" was the last hub revision which incorporated the pitch cylinder feature.

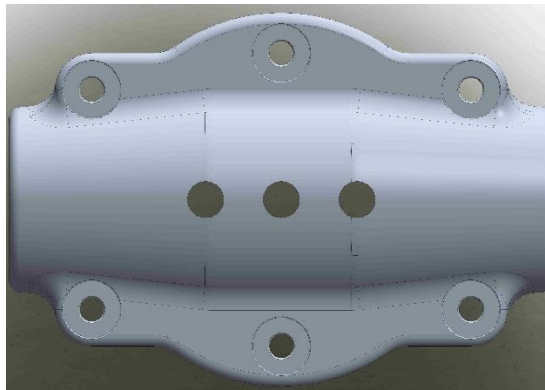
- Revision "E" or later 2A0 series hubs with three ½" diameter holes in the hub cover half are not affected. See Figure 2.

Figure 2. Hub Model 2A0 series Revision "E" and later

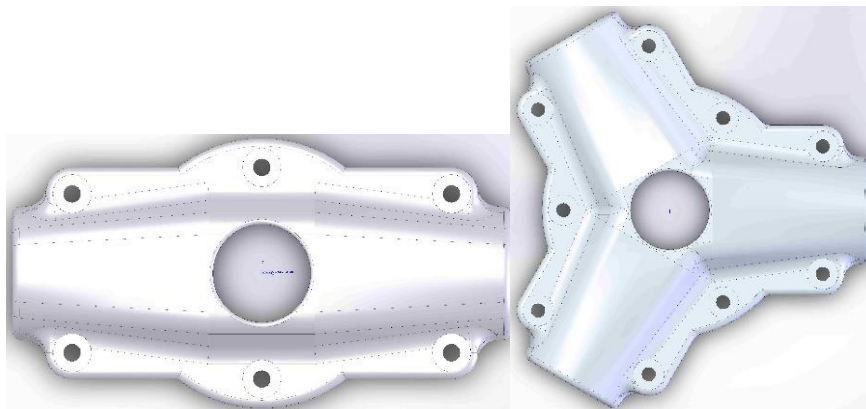
- Model 2A1R5 and 3A0B7 hubs with long blade shanks are not affected. While they do incorporate the white pitch cylinder, the blade retention geometry is significantly longer and different from the compact 2A0 series so that this service bulletin does not apply. See Figure 3.

Figure 3. Hub Models 2A1R5 and 3A0B7, respectively

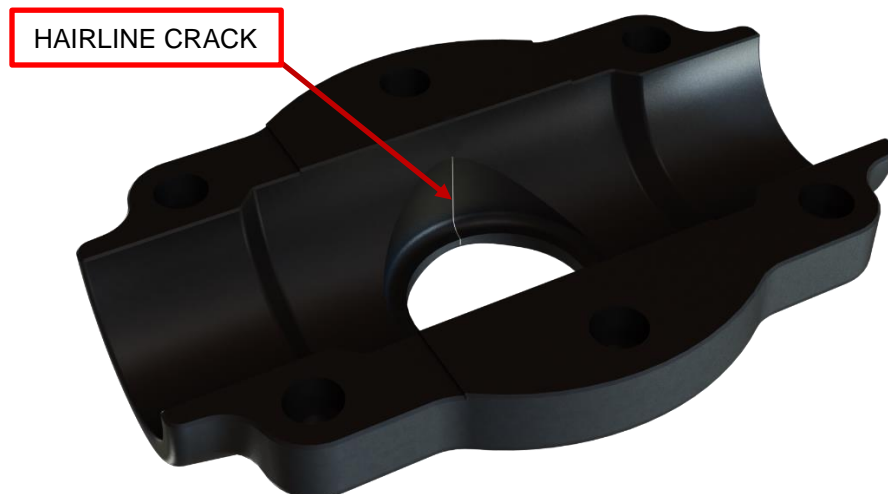
- The hub cracks typically start at or near the pitch marks on the sides of the central hole, and grow outwards towards the hub sides. They are hairline cracks which are very difficult to see with the naked eye. We recommend using very good lighting, a 10x magnifying glass and inspecting the inside of the pitch cylinder hole in the hub cover next to the pitch marks.
- See Figures 4 through 6 below. Figure 4 shows the best location for inspection, on the inside of the hub cover pitch cylinder hole.
- The hub cover must be removed from the propeller assembly for thorough inspection inside the pitch cylinder hole. *Inspection of the hub exterior is not adequate.*
- Hub color/plating does not appear to be a factor, but the black anodize makes inspection more difficult.
- This inspection must be performed every 50 flight hours or annually, whichever comes first.

Figure 4. Cracks start near pitch marks and grow outwards. Inspection inside the hub cover is required.

Inspect affected hub cover every 50 flight hours or annually, whichever comes first. This requires removal of the spinner dome and spinner front plate (if used) so that the inside of the hub cover can be inspected.

Replace affected hub cover half with new revision “D1” hub cover half. This replacement part will significantly reduce stress in the problem areas while adding only 74 grams (0.15 lbs) to the total propeller weight. It is a direct replacement and will fit and function with all current spinner assemblies.

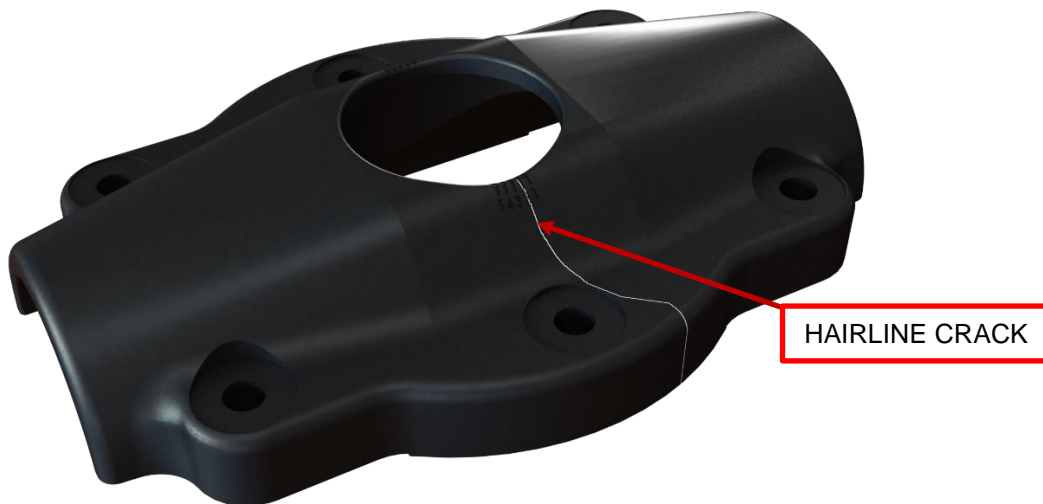
Figure 5. Unattended cracks may progress to edges of hub cover half.

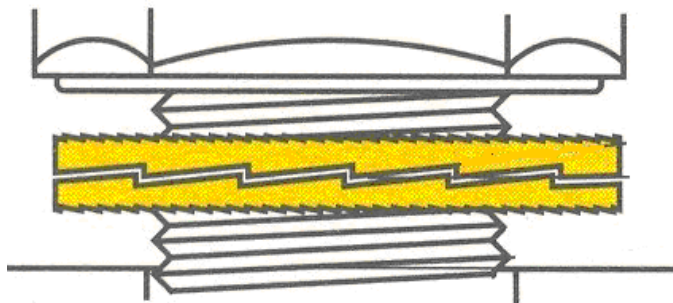
Nord-lock washers work in pairs with the ramped sides facing each other. See Figure 6.

During loosening, the Nord-lock washers may click loudly; this is normal. Inspect Nord-lock washers on the inside cam surfaces and outside serrations. Replace washers with excessive wear.

Figure 6. Nord-Lock Lock Washer

Lubricate acceptable washers with a light coating of engine oil or equivalent.

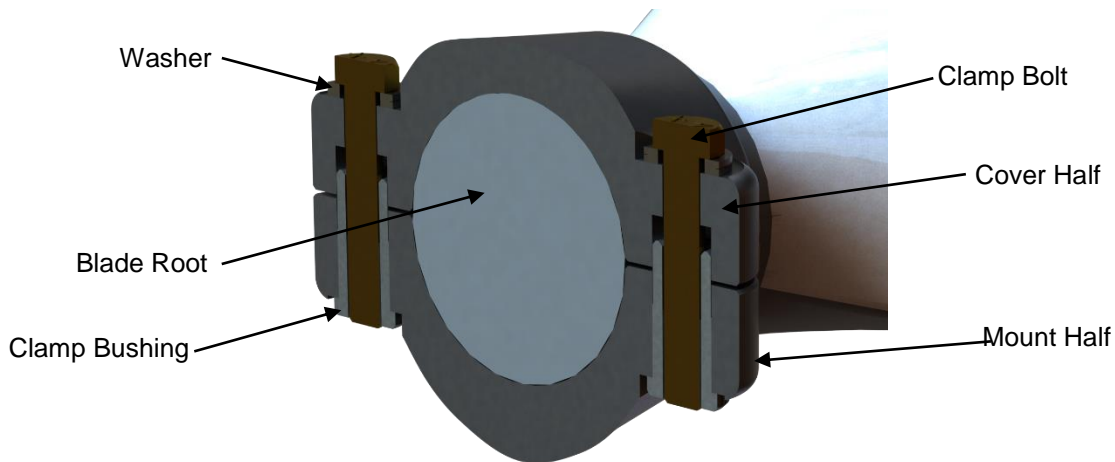
One design element which increases the retention safety for the 2A0 hub series is the incorporation of threaded clamp bushings. These bushings are press fit in the hub mount half and engage the hub cover half when the propeller blades are pitched and clamp bolts fully torqued. This ensures that the propeller clamp bolts do not carry any shear loads even if the hub cover cracks into two pieces.

NOTE: The clamp bushings provide blade retention backup *and do not change the 50 hour inspection interval for this service bulletin.*

Figure 6. Clamp Bushing Engagement into Hub Cover
