SENSENICH PROPELLER CO., INC.

SERVICE BULLETIN SB2016-06A
(Supersedes SB2016-06)

SUBJECT: Inspection of adjustable pitch hubs for cracks

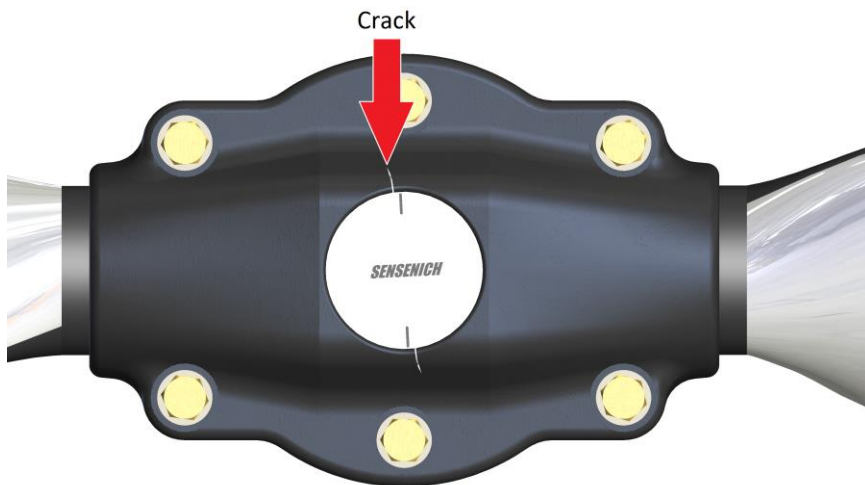
Figure 1. Cracks start near pitch marks and grow outwards.

- Inspect hub for cracks before next flight.
- Remove spinner dome (and front bulkhead, if used). Closely inspect the hub cover (clamp half) around the pitch cylinder and on the hub sides. Also examine the sides of the hub mount half. See Figures 1 and 2.
- Notify Sensenich of any crack occurrences and return hub for evaluation.
- Inspect hub for cracks every 50 hours or annually.

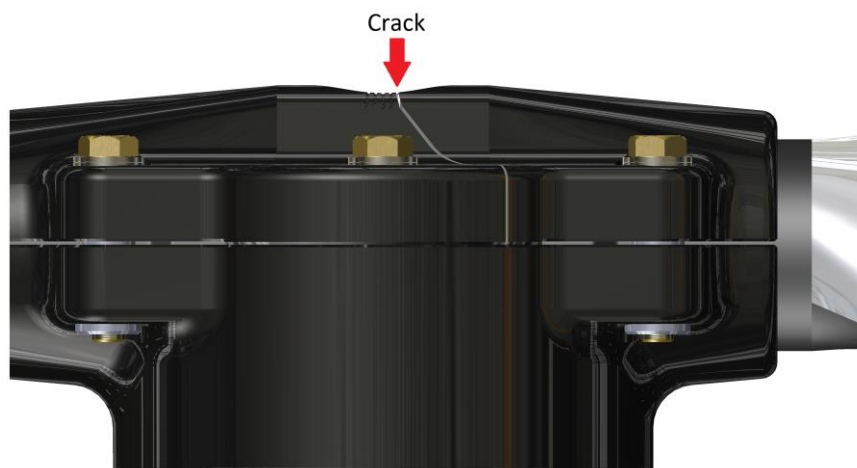
Figure 2. Unattended cracks may progress to edges of hub cover half.
