SENENICH PROPELLER CO., INC.

SERVICE BULLETIN SB2019-02

SUBJECT: Inspection of adjustable pitch hubs for cracks

- **2EK** 2 blade aircraft hubs with pitch cartridge for Continental or other direct drive engines.
- **2EL** 2 blade aircraft hubs with pitch cartridge for L or other reduction drive engines.

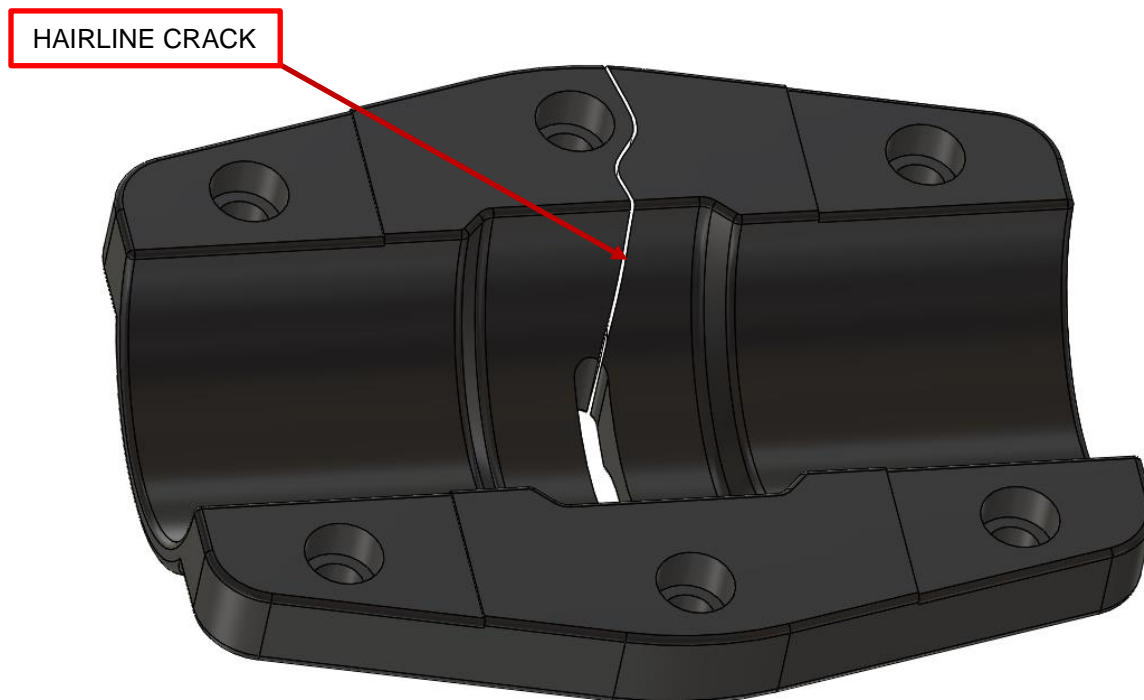
- The hub cracks typically start at or near the pitch cartridge slot on the sides of the central hole, and grow outwards towards the hub sides. They are hairline cracks which are very difficult to see with the naked eye. Refer to Figures 1 & 2 for crack location.

Figure 1. Cracks start near pitch marks and grow outwards.

- Using very good lighting and a 10x magnifying glass, inspect the inside of the pitch cartridge slot in the hub cover next to the pitch marks.
- The hub cover must be removed from the propeller assembly for thorough inspection inside the pitch cartridge slot. Inspection of the hub exterior is not adequate.

- Notify Sensenich of any crack occurrences and return affected hub for evaluation.
- Inspect affected hub for cracks every 50 hours or annually, whichever comes first.

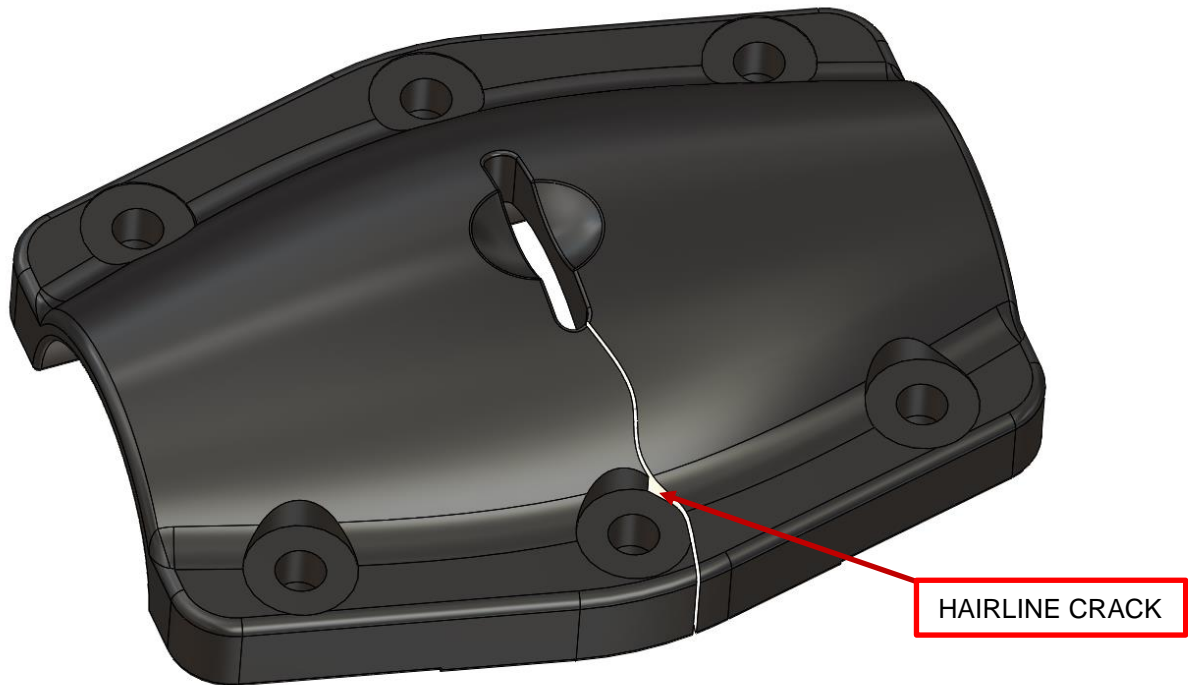
- The occurrence, if unattended, could result in the hub cover half cracking completely across.
- To date, there have been no inflight blade separations but the location of crack growth necessitates immediate inspection.

Figure 2. Unattended cracks may progress to edges of hub cover half.

- Replacement hub covers with revision “D” stamped after the serial number are not subject to this service bulletin or the 50 hour recurrent crack inspection.
