SENENICH PROPELLER CO., INC.

SERVICE BULLETIN SB2019-02A

SUBJECT: Inspection of adjustable pitch hubs for cracks

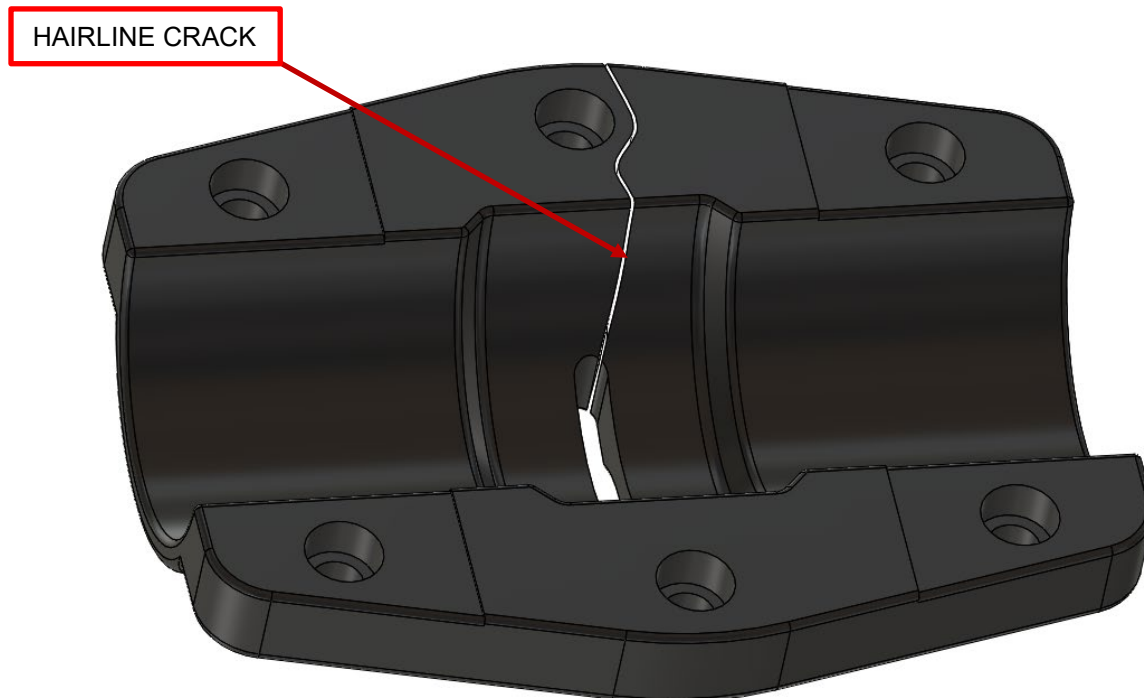
- The hub cracks typically start at or near the pitch cartridge slot on the sides of the central hole, and grow outwards towards the hub sides. They are hairline cracks which are very difficult to see with the naked eye. Refer to Figures 1 & 2 for crack location.

Figure 1. Cracks start near pitch marks and grow outwards.

- Using very good lighting and a 10x magnifying glass, inspect the inside of the pitch cartridge slot in the hub cover next to the pitch marks.
- The hub cover must be removed from the propeller assembly for thorough inspection inside the pitch cartridge slot. Inspection of the hub exterior is not adequate.

- Notify Sensenich of any crack occurrences and return affected hub for evaluation.
- Inspect affected hub for cracks every 50 hours or annually, whichever comes first.
