SENSENICH PROPELLER MANUFACTURING COMPANY, INC.

SERVICE BULLETIN #R-11 MARCH 1, 1966

SUBJECT: INSPECTION OF MID-BLADE AREA OF MT6EMM AND M76EMMS PROPELLERS

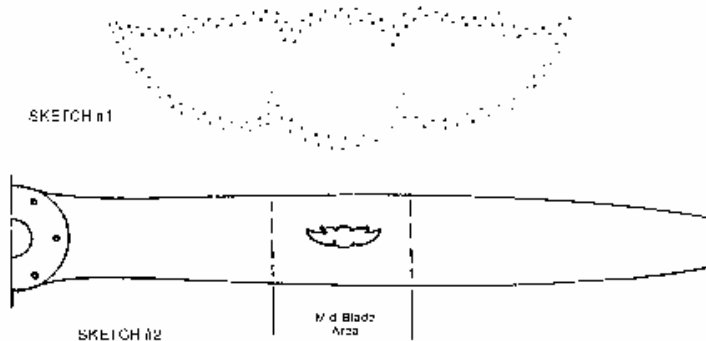
Sensenich Propeller Bulletin No. R-10 dated 4 January 1965, required the removal of the mid-blade decal so that the area under and adjacent to the decal could be examined for corrosion pits. These corrosion pits had, in some cases, initiated a fatigue crack which resulted in a failure of the propeller blade. These corrosion pits are clusters of tiny black dots (see sketch #1) which appear most frequently under the narrow black border of the decal.

It now appears that some owners, when attempting to comply with Bulletin R-10, were looking for a white powdery corrosion and failed to notice the small black dots. The new style epoxy adhesive decal was then installed over these corrosion pits. For this reason, and to ensure that all propellers are properly inspected, the mid-blade decals must be removed. The decals should be soaked with paint remover and rubbed off with a rag; they must not be scraped or sanded off. The mid-blade area (sketch #2) must be thoroughly re-inspected with a glass of approximately 3 power.

If a crack is found, the propeller must be replaced immediately. If corrosion pits (the tiny black dots) are discovered they must be removed within the next 20 hours of operation. They can be removed in the following manner: (1) Sand the area with 220 grit wet-or-dry abrasive paper and polish with 320 grit or finer. (2) Clean the area thoroughly and apply a dye penetrant. (3) Inspect with a low-power glass; it is very important that the bottom of the pits be completely removed. If the pits re-appear, repeat the operations. (4) When the pits are completely removed, spray the area with a clear lacquer.
