**SENSENICH PROPELLER CO., INC.**

**SERVICE BULLETIN SB2016-06B**  
**(Supersedes SB2016-06A)**

**SUBJECT:** Inspection of adjustable pitch hubs for cracks

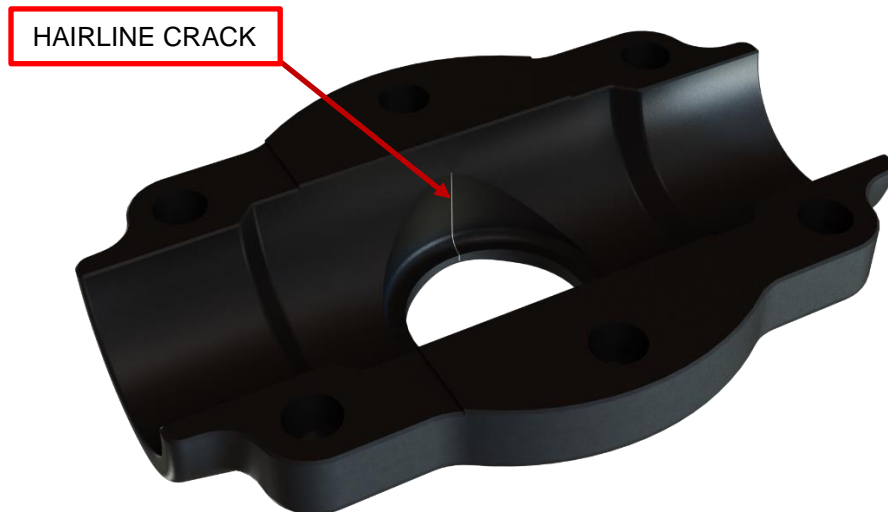
- The hub cracks typically start at or near the pitch marks on the sides of the central hole, and grow outwards towards the hub sides. They are hairline cracks which are very difficult to see with the naked eye. Refer to Figures 1 & 2 for crack location.

Figure 1. Cracks start near pitch marks and grow outwards.

- Using very good lighting and a 10x magnifying glass, inspect the inside of the pitch cylinder hole in the hub cover next to the pitch marks.
- The hub cover must be removed from the propeller assembly for thorough inspection inside the pitch cylinder hole. Inspection of the hub exterior is not adequate.

- Notify Sensenich of any crack occurrences and return affected hub for evaluation.
- Inspect affected hub for cracks every 50 hours or annually, whichever comes first.

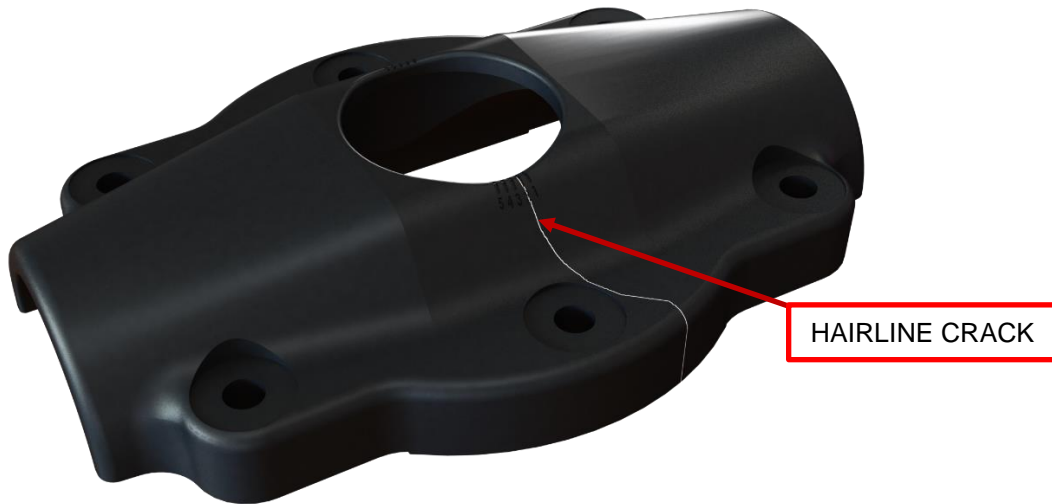
- The occurrence, if unattended, could result in the hub cover half cracking completely across.
- To date, there have been no inflight blade separations but the location of crack growth necessitates immediate inspection.

Figure 2. Unattended cracks may progress to edges of hub cover half.
