SENSENICH PROPELLER CO., INC.

August 12, 2024

FAQ FOR SERVICE BULLETIN SB2016-06B1

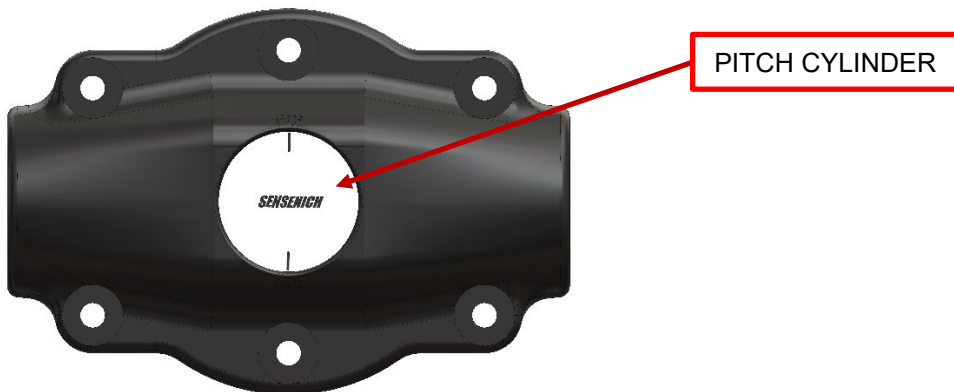
Models 2A0J5 and 2A0R5, revision "0", "A", "B", "C", and "D".

Figure 1. Hub Model 2A0 Series Revision "D" and earlier

Identification is denoted by the presence of the white pitch cylinder.

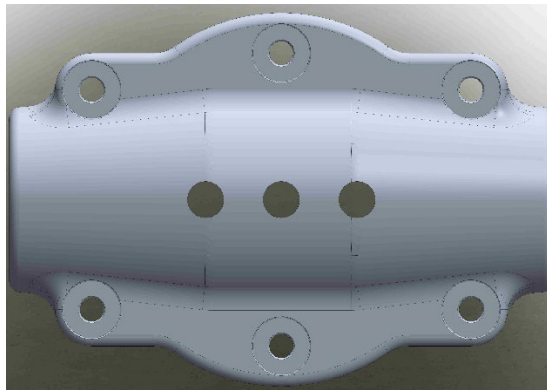
- Revision "E" or later 2A0 series hubs with three ½" diameter holes in the hub cover half are not affected. See Figure 2.

Figure 2. Hub Model 2A0 series Revision "E" and later

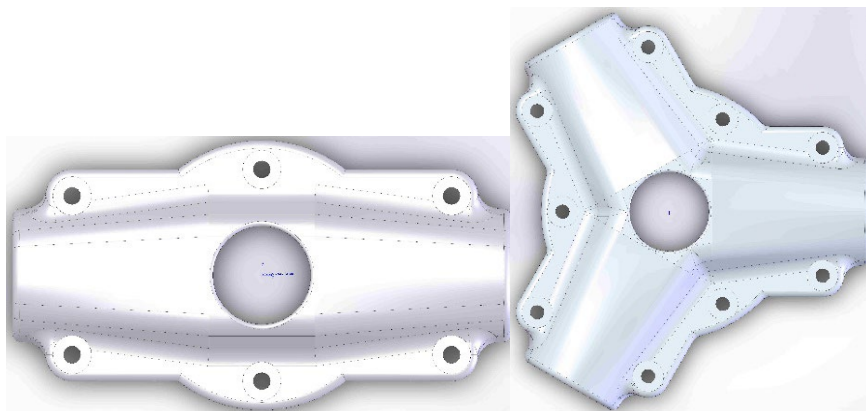
- Model 2A1R5 and 3A0B7 hubs with long blade shanks are not affected. While they do incorporate the white pitch cylinder, the blade retention geometry is significantly longer and different from the compact 2A0 series so that this service bulletin does not apply. See Figure 3.

Figure 3. Hub Models 2A1R5 and 3A0B7, respectively

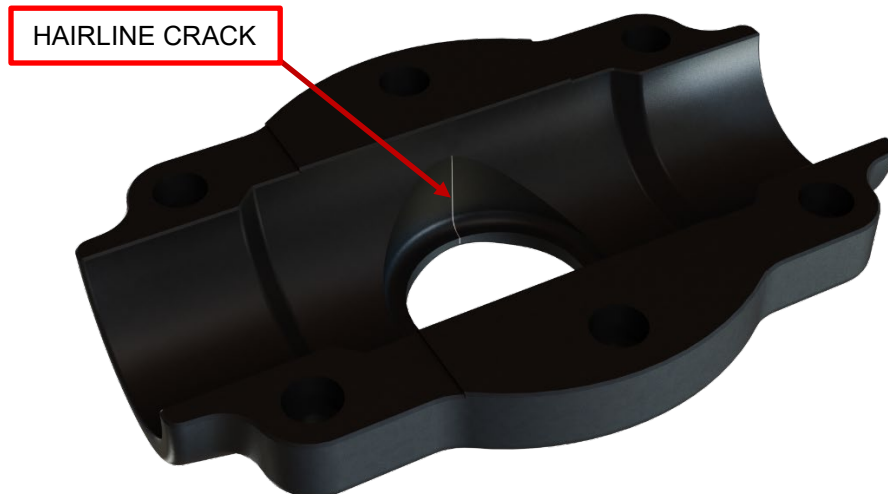
- The hub cracks typically start at or near the pitch marks on the sides of the central hole, and grow outwards towards the hub sides. They are hairline cracks which are very difficult to see with the naked eye. We recommend using very good lighting, a 10x magnifying glass and inspecting the inside of the pitch cylinder hole in the hub cover next to the pitch marks.
- See Figures 4 through 6 below. Figure 4 shows the best location for inspection, on the inside of the hub cover pitch cylinder hole.
- The hub cover must be removed from the propeller assembly for thorough inspection inside the pitch cylinder hole. *Inspection of the hub exterior is not adequate.*
- Hub color/plating does not appear to be a factor, but the black anodize makes inspection more difficult.
- This inspection must be performed every 50 flight hours or annually, whichever comes first.

Figure 4. Cracks start near pitch marks and grow outwards. Inspection inside the hub cover is required.

Inspect affected hub cover every 50 flight hours or annually, whichever comes first. This requires removal of the spinner dome and spinner front plate (if used) so that the inside of the hub cover can be inspected.

Replace affected hub cover half with new revision “D1” hub cover half. This replacement part will significantly reduce stress in the problem areas while adding only 74 grams (0.15 lbs) to the total propeller weight. It is a direct replacement and will fit and function with all current spinner assemblies.

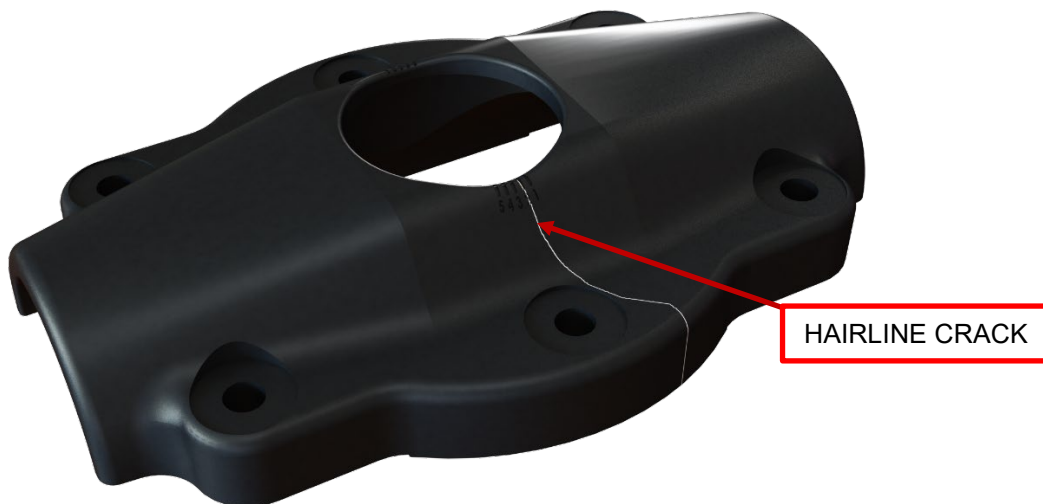
Figure 5. Unattended cracks may progress to edges of hub cover half.

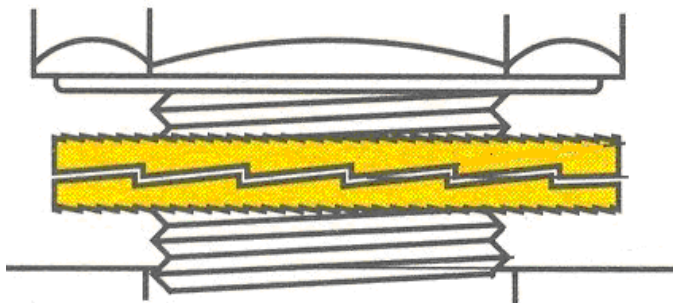
Nord-lock washers work in pairs with the ramped sides facing each other. See Figure 6.

Figure 6. Nord-Lock Lock Washer

During loosening, the Nord-lock washers may click loudly; this is normal. Inspect Nord-lock washers on the inside cam surfaces and outside serrations. Replace washers with excessive wear.

Lubricate acceptable washers with a light coating of engine oil or equivalent.

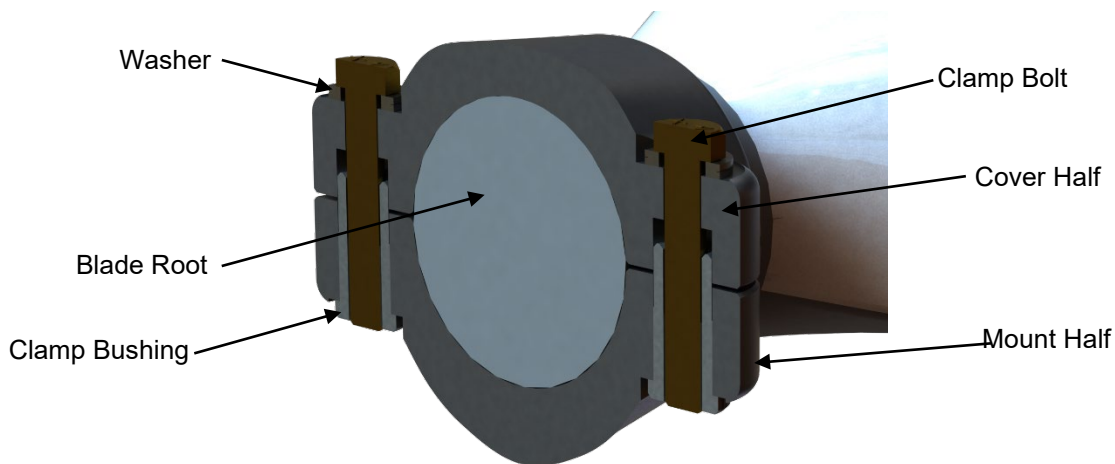
One design element which increases the retention safety for the 2A0 hub series is the incorporation of threaded clamp bushings. These bushings are press fit in the hub mount half and engage the hub cover half when the propeller blades are pitched and clamp bolts fully torqued. This ensures that the propeller clamp bolts do not carry any shear loads even if the hub cover cracks into two pieces.

NOTE: The clamp bushings provide blade retention backup *and do not change the 50 hour inspection interval for this service bulletin.*

Figure 6. Clamp Bushing Engagement into Hub Cover
