SENSENICH PROPELLER CO., INC.

SERVICE BULLETIN SB2016-06B1
(Supersedes SB2016-06B)

SUBJECT: Inspection of adjustable pitch hubs for cracks

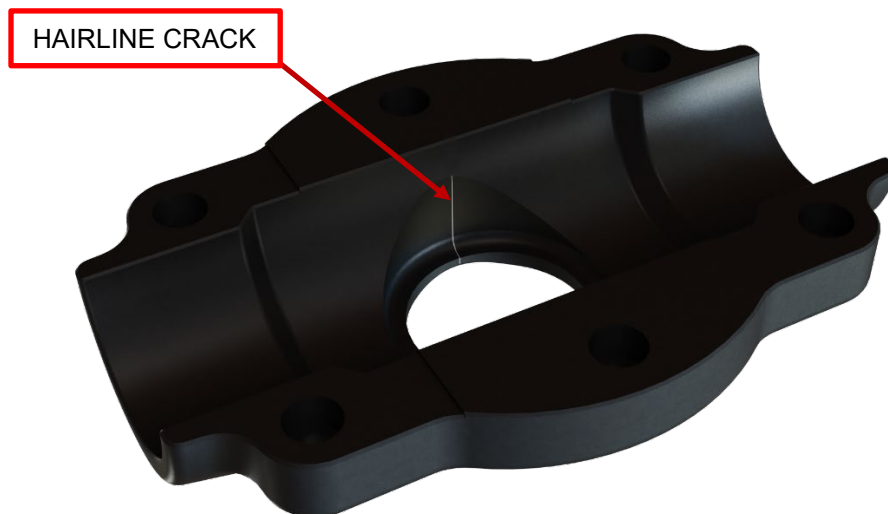
- The hub cracks typically start at or near the pitch marks on the sides of the central hole, and grow outwards towards the hub sides. They are hairline cracks which are very difficult to see with the naked eye. Refer to Figures 1 & 2 for crack location.

Figure 1. Cracks start near pitch marks and grow outwards.

- Using very good lighting and a 10x magnifying glass, inspect the inside of the pitch cylinder hole in the hub cover next to the pitch marks.
- The hub cover must be removed from the propeller assembly for thorough inspection inside the pitch cylinder hole. Inspection of the hub exterior is not adequate.

- Notify Sensenich of any crack occurrences and return affected hub for evaluation.
- Inspect affected hub for cracks every 50 hours or annually, whichever comes first.

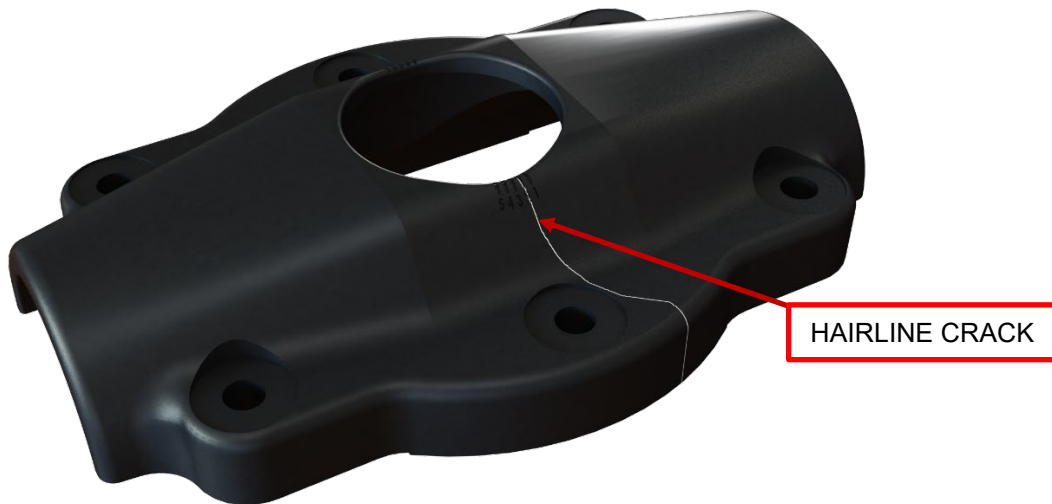
- The occurrence, if unattended, could result in the hub cover half cracking completely across.
- To date, there have been no inflight blade separations but the location of crack growth necessitates immediate inspection.

Figure 2. Unattended cracks may progress to edges of hub cover half.
