SENENICH WOOD PROPELLER CO., INC.

SUPPLEMENTAL AIRWORTHINESS INSTRUCTIONS FOR BONDED METAL EROSION SHIELD

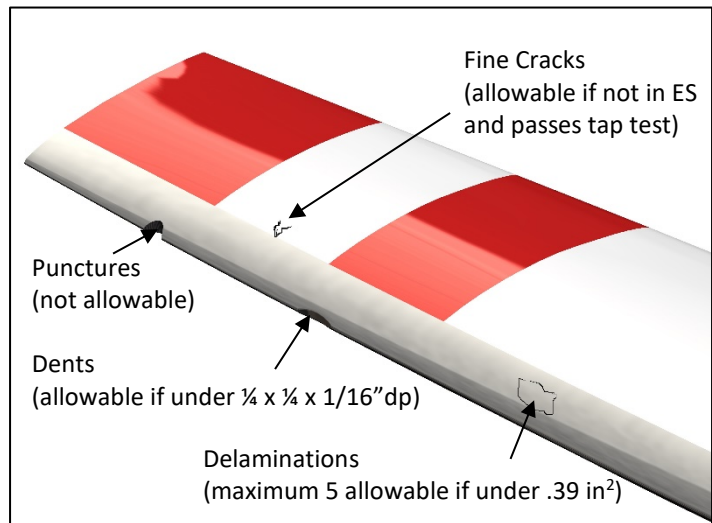
EROSION SHIELD DAMAGE LIMITATIONS OF SAFE OPERATION

If your erosion shield begins to show any of the following damage, it should be removed from service and inspected by a rated repair station before next operation:

- 1) Any dent or erosion that punctures the erosion shield or exposes composite or core material underneath.
- 2) Any dent or erosion greater than 1/16" deep.
- 3) Circular or pointed dents greater than ¼ x ¼".
- 4) Any cracks in the metal erosion shield.
- 5) Any debond greater than .39 in².
- 6) Any debond greater than 1" spanwise length.
- 7) Any debond greater than 30% of the erosion shield width.
- 8) Debonds within 5 inches of each other.
- 9) More than 5 debonds of any size.

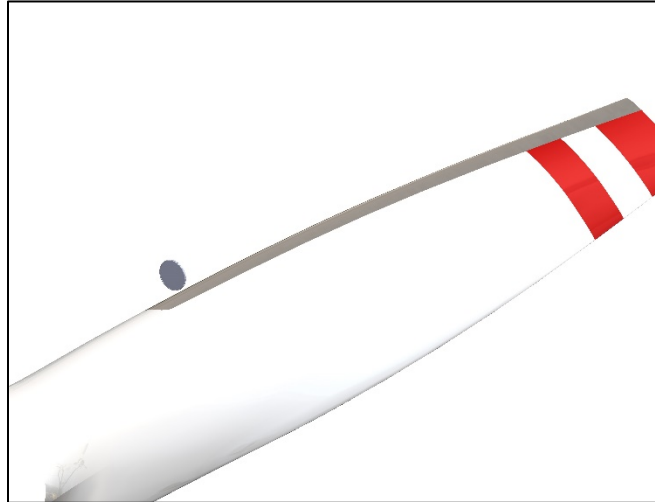
COIN TAP TEST

Debonds and delaminations within the laminate or under the erosion must be inspected for using a coin tap test. Using a coin or washer similar in size to a quarter, tap the entire surface of the erosion shield and blade. Solid laminate will produce a high pitch note. Debonded or delaminated areas will have a hollow, dead response.
