SENENICH WOOD PROPELLER CO., INC.

SUPPLEMENTAL AIRWORTHINESS INSTRUCTIONS FOR BONDED METAL EROSION SHIELDS

Revision A, Dated 8-14-2018

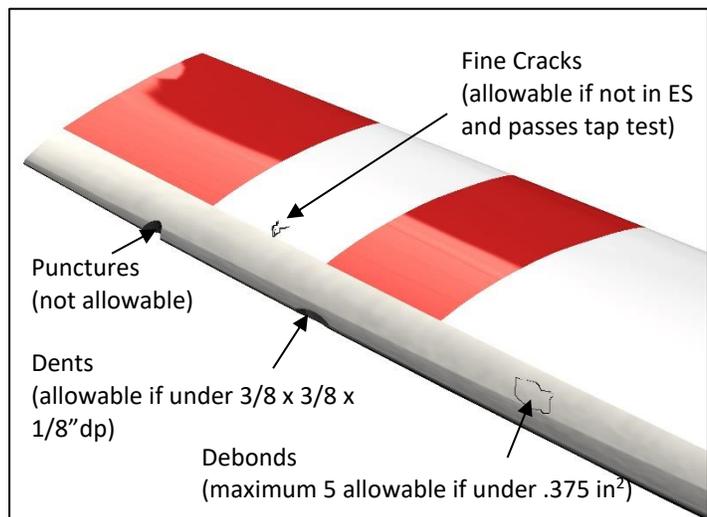
EROSION SHIELD DAMAGE LIMITATIONS FOR SAFE OPERATION

If your erosion shield begins to show any of the following damage, it should be removed from service and inspected by a rated repair station before next operation:

- 1) Any dent or erosion that punctures the erosion shield or exposes composite or core material underneath.
- 2) Any dent or erosion greater than 1/8" deep.
- 3) Circular or pointed dents greater than 3/8 x 3/8".
- 4) Any cracks in the metal erosion shield.
- 5) Any debond greater than .375 in².
- 6) Any debond greater than 1" length along the blade.
- 7) Debonds with less than 5" separation.
- 8) More than 5 debonds of any size in a single erosion shield.

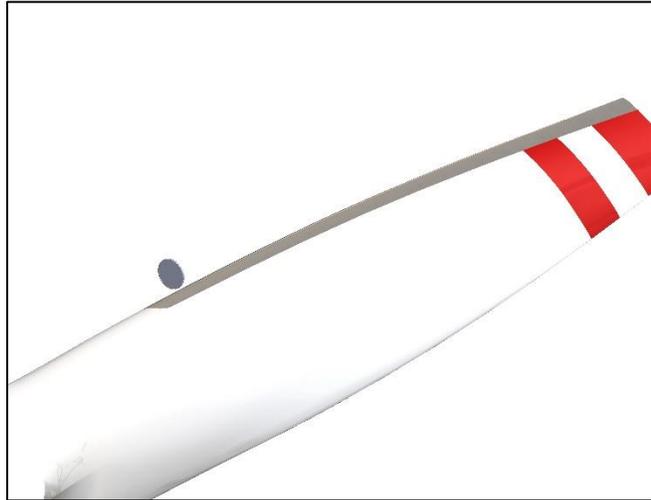
COIN TAP TEST

Debonds and delaminations within the laminate or under the erosion must be inspected by industry standard tap test. Using a coin or washer similar in size to a quarter, tap the entire surface of the erosion shield and blade. Solid laminate will produce a high pitch note. Debonded or delaminated areas will have a hollow, dead response. Mark debond and delam areas as the erosion shield and surrounding area are tap tested.
