## SENSENICH PROPELLER MANUFACTURING COMPANY, INC.

## SERVICE BULLETIN #R-12A FEBRUARY 6, 1967

**SUBJECT:** REMOVAL OF MID-BLADE DECALS AND INSPECTION OF MID- BLADE AREA FOR CORROSION PITS AND CRACKS

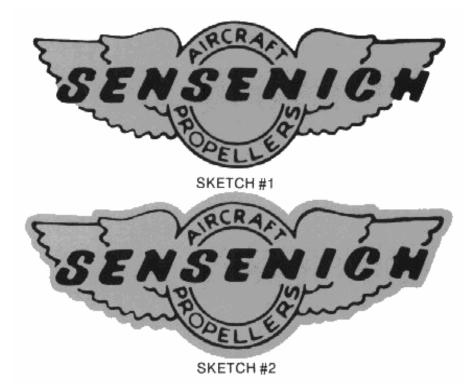
Sensenich Propeller <u>Bulletin Number R-11</u> dated March 1,1966 and FAA Airworthiness Directive 66-11-3 dealt with the problem of corrosion pits found in the area of the mid-blade propeller decal. Instances of corrosion pits under and in the immediate area of the mid-blade decal have been discovered in M74DC and M74DM propellers carrying Beech decals and other models of Sensenich fixed-pitch metal propellers with Sensenich decals attached by a water-soluble adhesive. The Sensenich decals can be identified by their black border (sketch #1). Later Sensenich epoxy-adhesive decals (with a narrow gold border outside the black, sketch #2) are satisfactory. Water-soluble decals must not be reinstalled.

These decals must be removed by soaking with paint remover and rubbing off with a rag; they must not be scraped or sanded off. The mid-blade area must be thoroughly inspected with a glass of at least 3 power. If a crack or corrosion pits deeper than .015 inch are found, the propeller must be replaced before further flight. If corrosion pits (tiny black dots) are discovered, they must be removed within the next twenty hours of operation. They can be removed in the following manner:

- 1. Sand the area with 220 grit wet-or-dry abrasive paper and polish with 320 grit or finer.
- 2. Clean the area thoroughly and apply a dye penetrant.
- 3. Inspect with a low-power glass; it is very important that the bottom of the pits be completely removed. If the pits re-appear, repeat the operations.
- 4. When the pits are completely removed, spray the area with a clear lacquer.
